INVENTORY OF
SIGNIFICANT
STRUCTURES

ARCHITECTURAL CHARACTER GUIDELINES

SEQUOIA &
KINGS CANYON
NATIONAL
PARKS

Laura Soullière Harrison
Architectural Historian
National Park Service
Southwest Regional Office
February, 1989

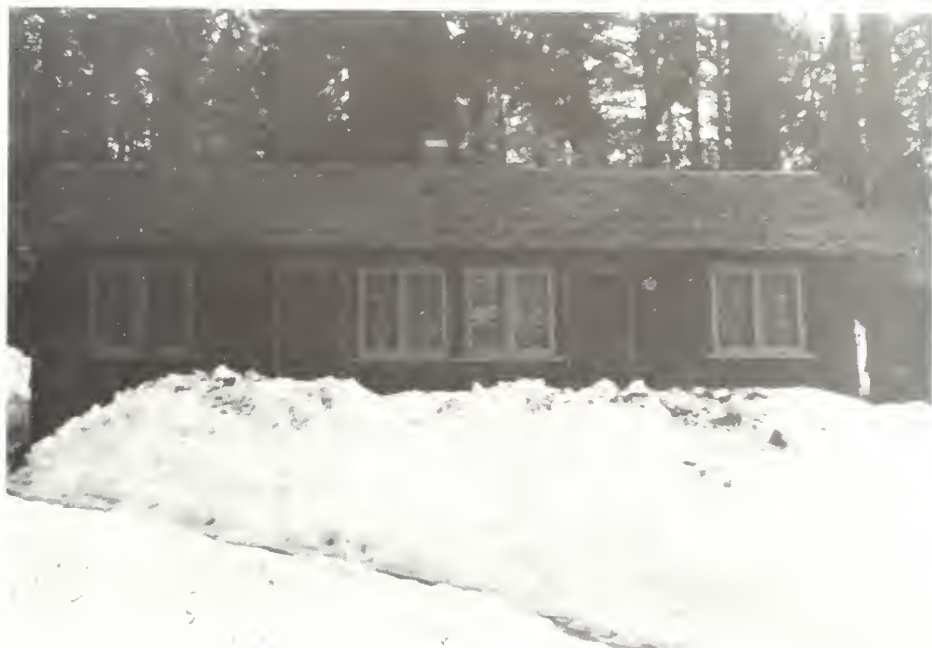
Building: Grant Grove Village Cabin 3-4

This small cottage is part of the complex of identical rustic cabins of Grant Grove village. Like the cabins of Giant Forest, the collection of these cottages is more important than the individual building. The structure's character-defining features are: the shake exterior walls; the wood-shingle gable roof with double-coursing every fifth row; the paired, six-light casement windows; the thick plank doors with wrought-iron hardware; the traditional dark reddish-brown color with lichen-green trim; and its informal layout as part of the group of cabins.

The building is scheduled for demolition so that new concessions facilities can be constructed in Grant Grove. Architect Gilbert Stanley Underwood designed the building.

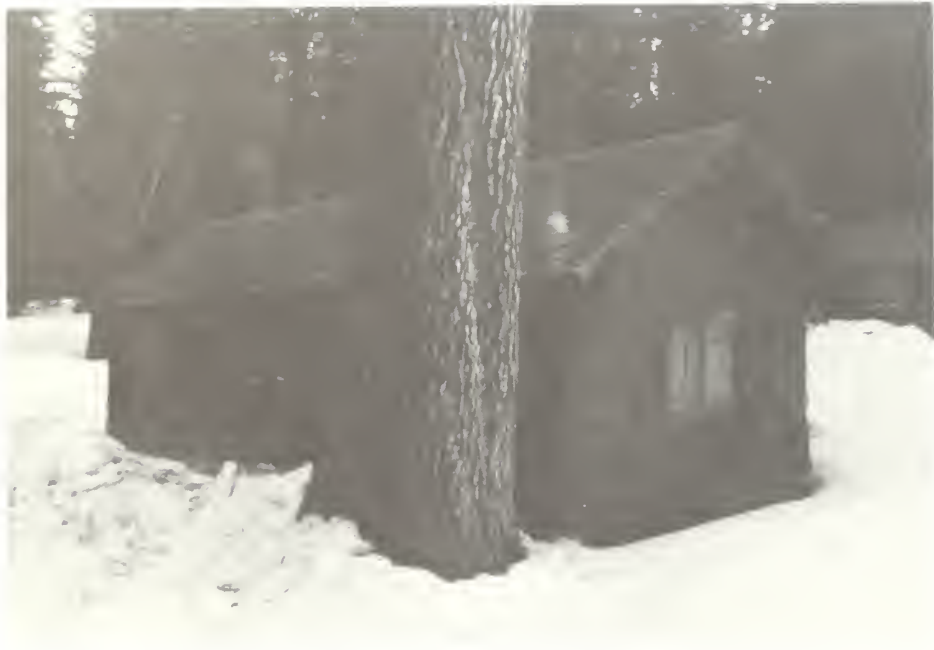
Building: Grant Grove Village Cabin 5-6

This cottage, too, is part of the complex of identical rustic cottages of Grant Grove Village. Again, the group of cottages is more important than the individual structures. The building's character-defining features are: the shake exterior walls; the wood-shingle gable roof with double-coursing every fifth row; the paired, six-light casement windows; the bracketed and beveled outlookers; the traditional brown color with lichen-green trim; and the building's placement in the informal layout of the group.

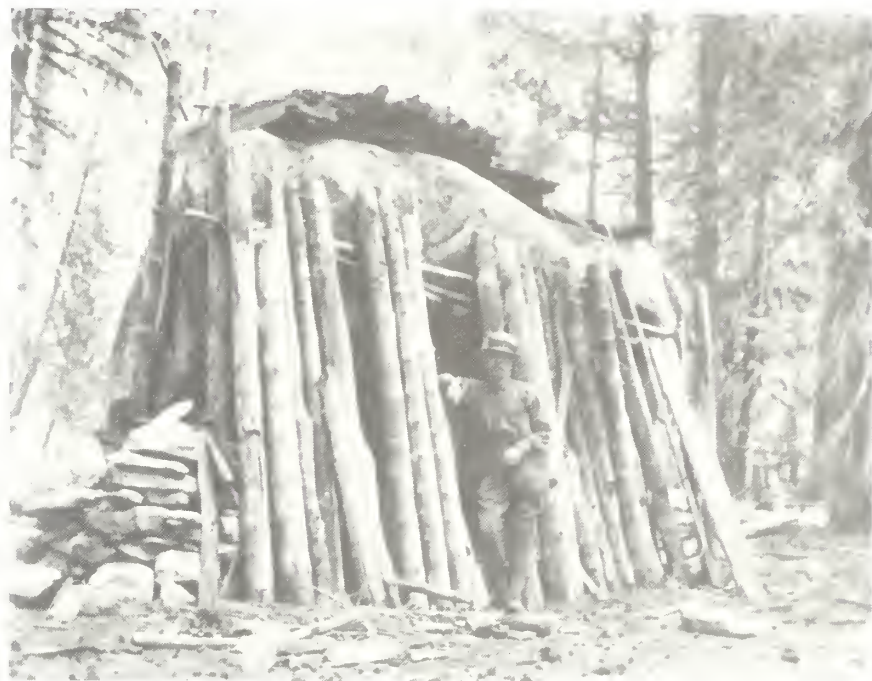
In the late nineteenth century, primitive shelters such as this one constructed by hunter and trapper James Wolverton, were common in the Sierra Nevada. Just as Hale Tharp did with Tharp's log, Wolverton enhanced a natural feature and turned it into a shelter. This large boulder had a natural overhang. Wolverton added a front wall of poles, a rubble chimney, and some additional roofing materials. This photograph shows the structure in 1947, decades after its abandonment.

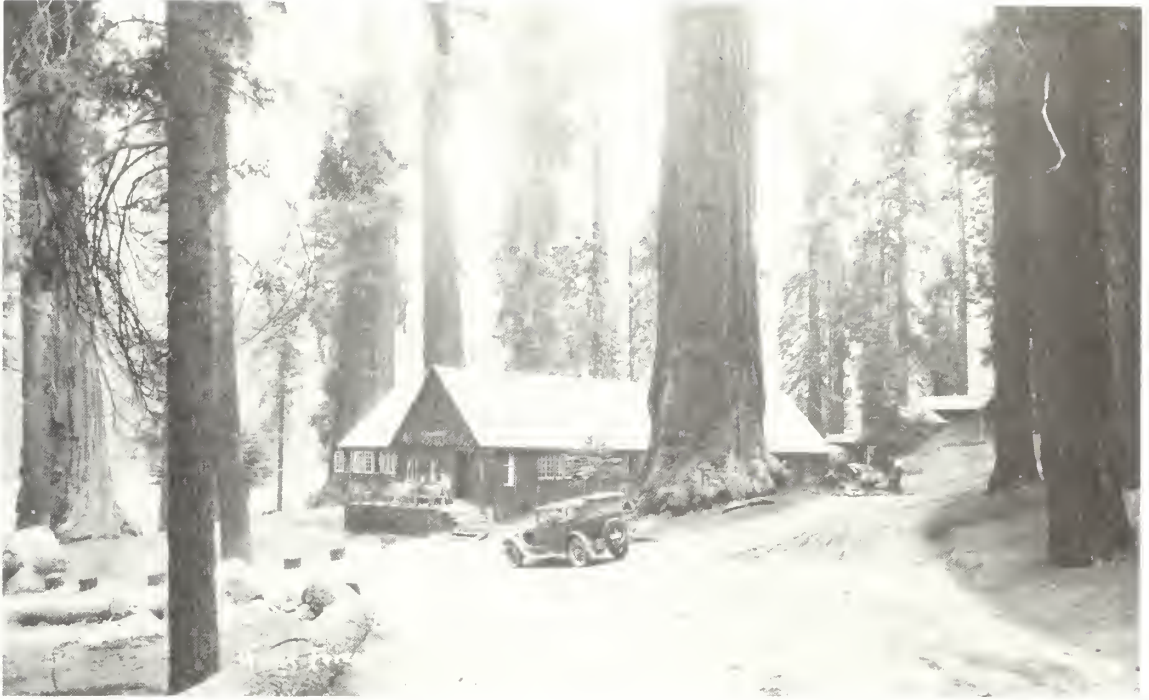
The main building of Giant Forest Lodge (circa 1920) sported a shake roof and Sequoia bark siding. The bright green paint around the window frames and mullions duplicated the green lichen that frequently appeared on adjacent fir trees. Although this building had a simple, functional form, its exterior materials tied the building with its setting.

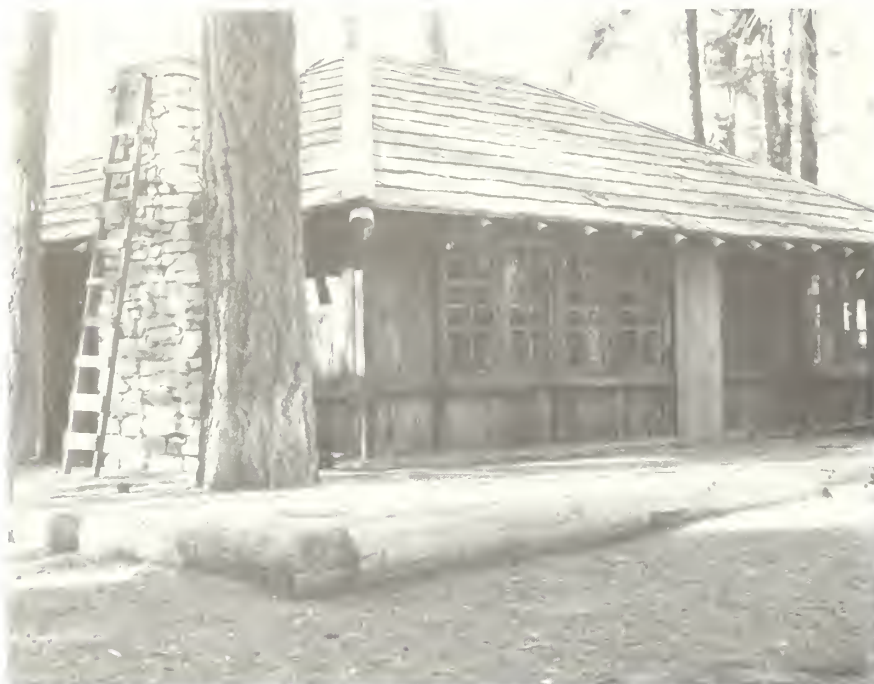
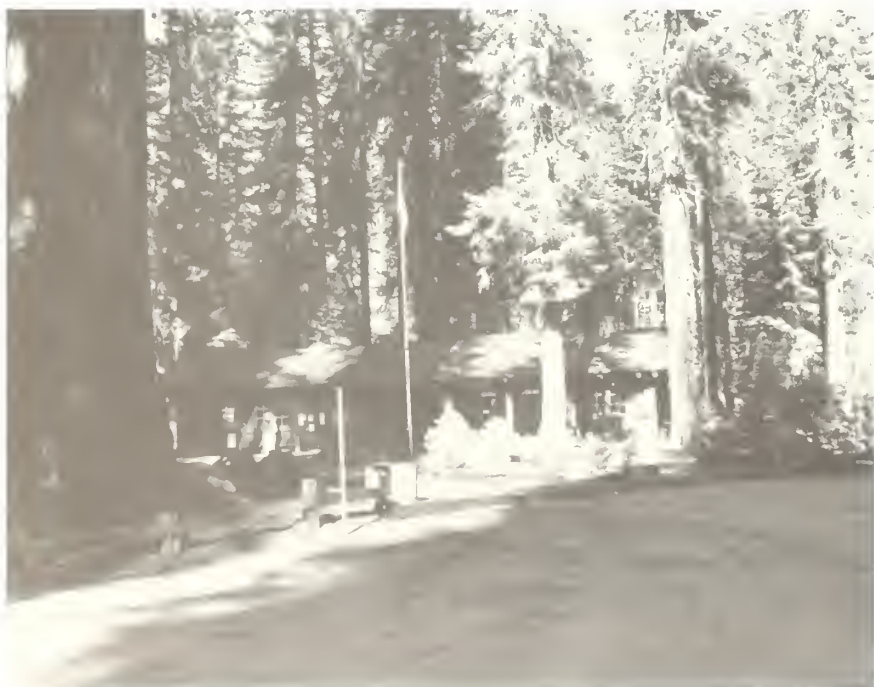
In the early 1920s the National Park Service established a strong physical presence in Giant Forest. The superintendent's residence (above) and the Giant Forest museum (below) established the agency's architectural direction. Hewn timber frames separated wall areas of sequoia-bark infill. Rubble masonry chimneys added to the buildings' rustic character. Exposed-frame construction continued in popularity through the 1960s. Post-World War II construction, however, lacked the strength of character that the earlier buildings possessed.

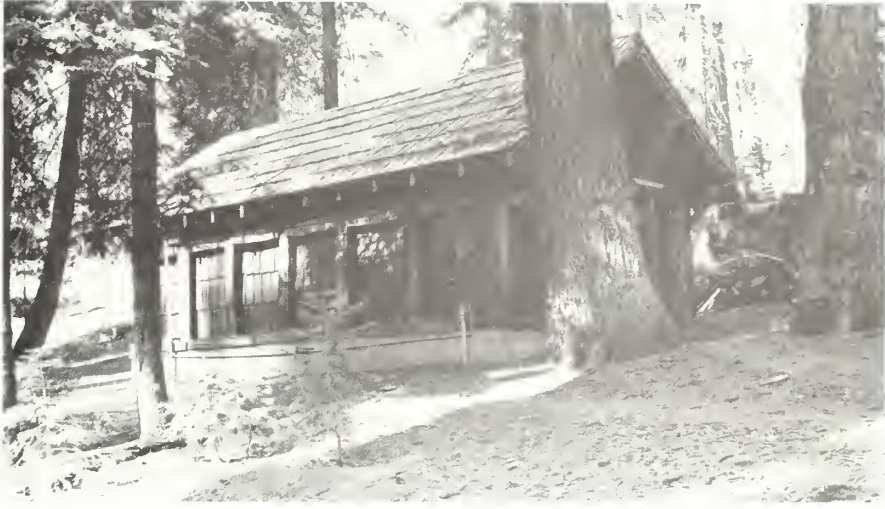
A simple style developed for utilitarian Park Service structures such as this comfort station in Giant Forest. Following the rustic pattern established by the earlier Park Service buildings in Giant Forest, the exposed framing defined the building's edges and structure. The shake infill added the rough texture equivalent to the roughness of the surrounding trees.

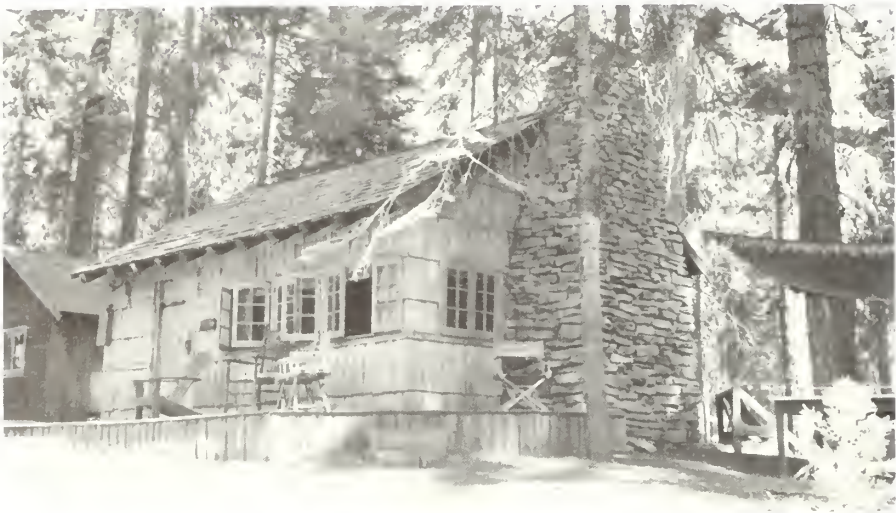
In 1921 the concessions operation constructed this rustic cabin as the writing room for guests of Giant Forest Lodge. The gentle batter of the chimney, the rough shake exterior, the wood shingle roof, and the wrought-iron hinges contributed to the structure’s rusticity. Architect Herbert Maier, who later designed a number of National Park museums and influenced the designs of hundred CCC structures, designed this building.

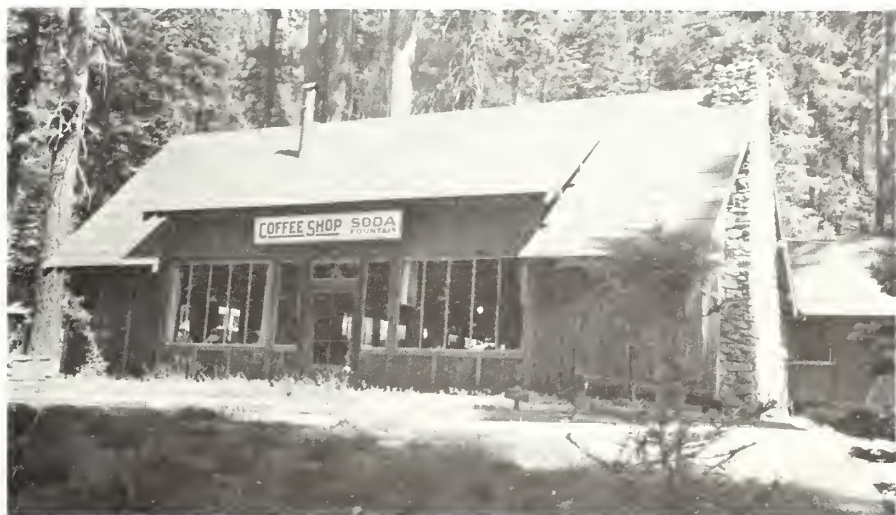
As part of upgrading concessions facilities during the late 1920s, architect Gilbert Stanley Underwood designed a market and photography studio. The latter, depicted here in a 1938 photograph, had many elements of the style that had developed for the Giant Forest area: the exposed frame with bark infill, the granite rubble chimney, and the wood-shingle roof. Double-coursing the shingles every fifth row relieved the flatness and monotony of the roof finish.

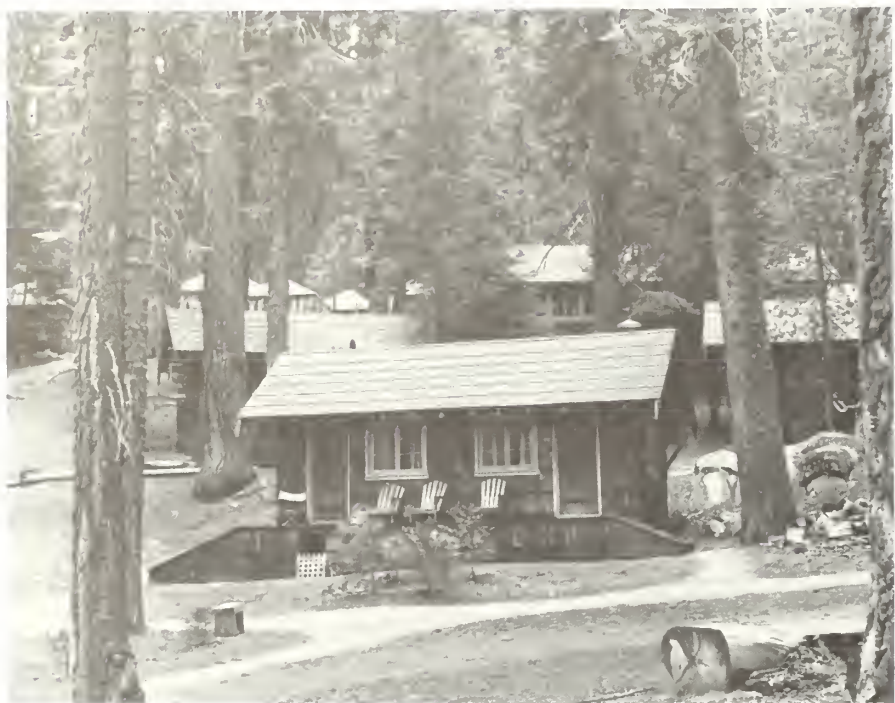
The concessioner offered a variety of overnight accommodations in Giant Forest. The small duplexes (above) dated from 1921. Their shake exteriors, lichen-green trim, wood-shingled roofs, and wrought-iron door hardware were carefully repeated in cottage after cottage. Architect Herbert Maier designed these buildings. The cleaner lined cottages of the mid-1930s (below) had enough architectural variety to defy boredom. Vertical siding defined the corners. Horizontal siding covered the remaining wall spaces. The shingle pattern added even more texture.

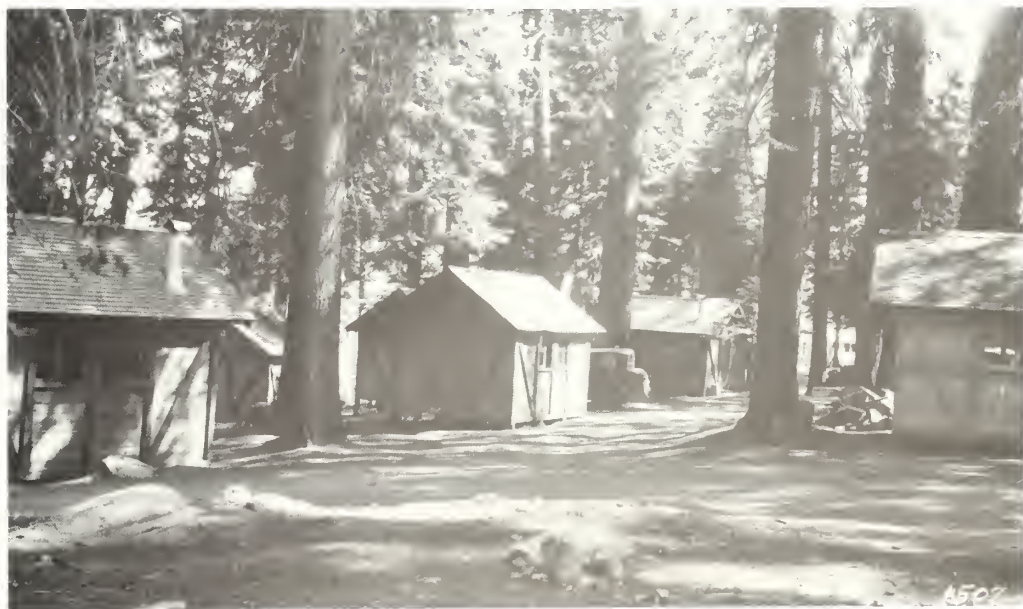
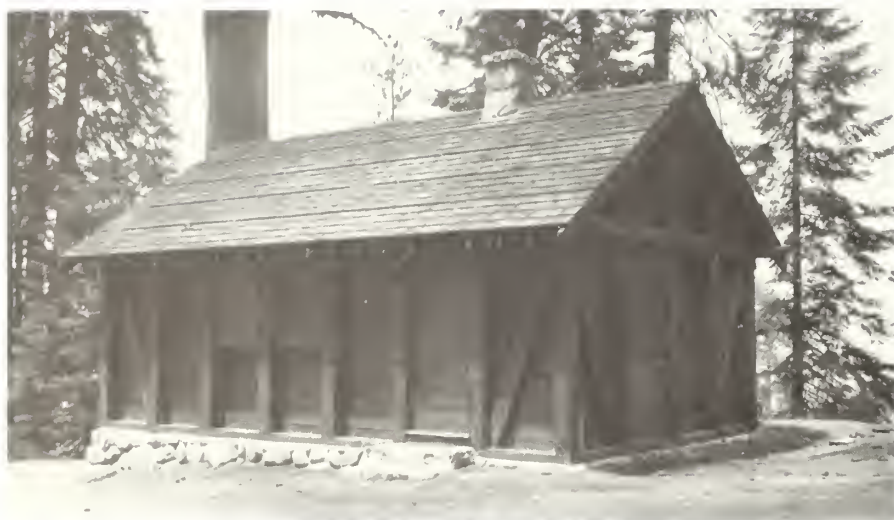
During the 1930s the six-year plans for Lodgepole and Giant Forest called for buildings with "heavy frame type" construction such as that seen here in the Last Hill dormitory. The rubble-veneer foundation, thick structural members, and roof shingling pattern developed into a consistent style for comfort stations and small utilitarian structures.

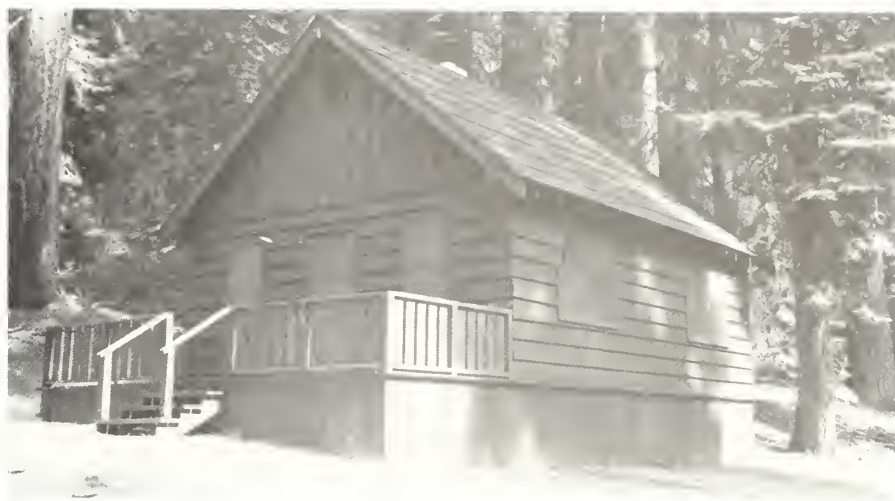
Other buildings at the 7,000-foot elevation possessed a decidedly rustic air. The vertical board-and-batten siding in the gable ends provided a counterpoint to the wide, horizontal boards of the principle siding. The buildings possessed both style and practicality. Above is B-89, a seasonal residence at Wolverton. Below is the Lodgepole Fire Dormitory.

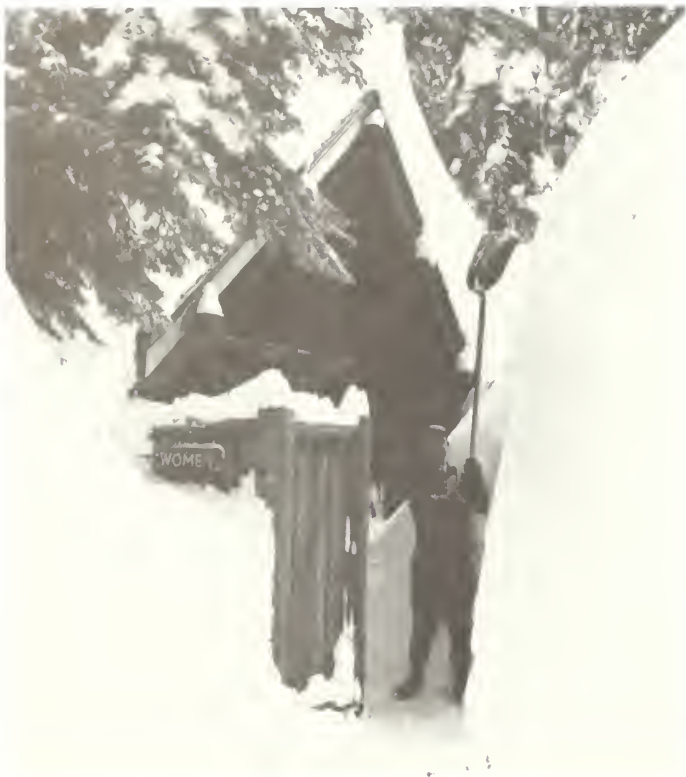
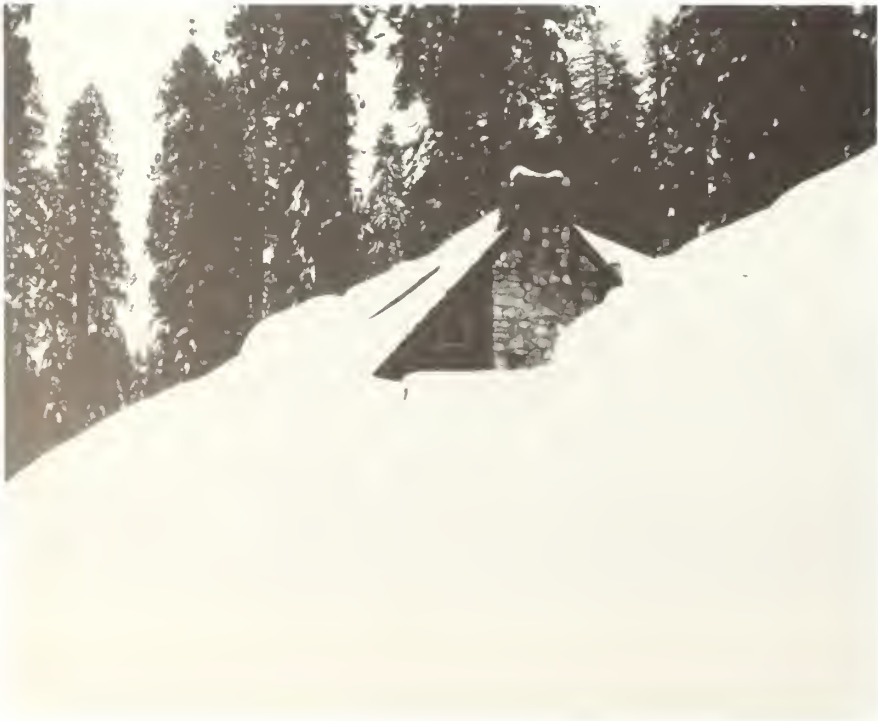
Heavy snows have caused considerable stress to buildings in the higher elevations. In 1952 (above), 1969 (below), and 1983, record snows buried buildings under tons of snow.

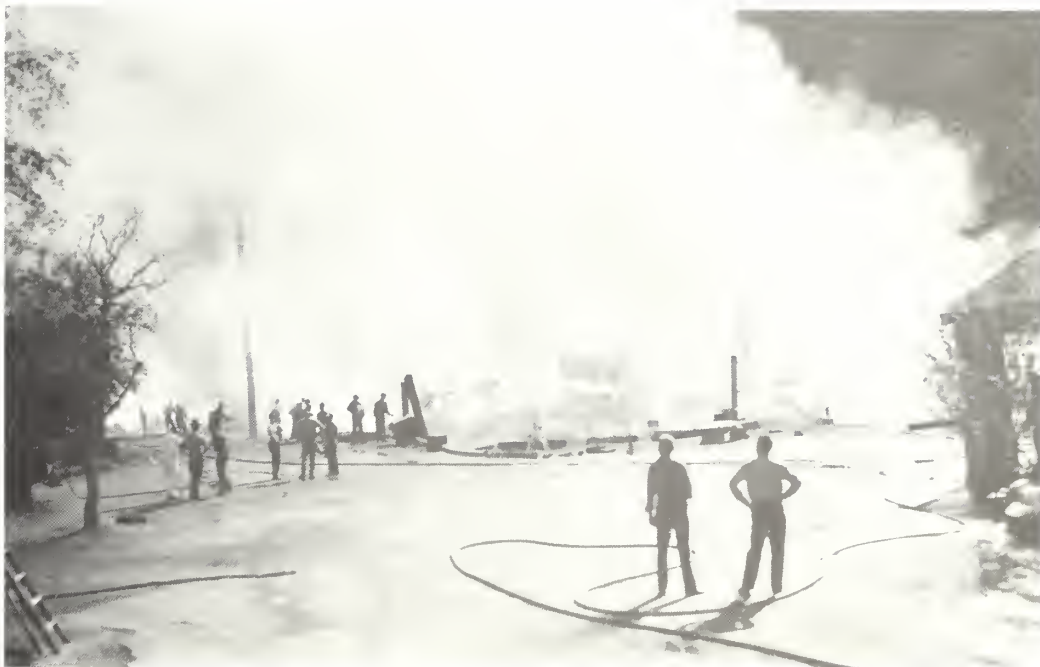
The Ash Mountain fire of November 11, 1939 destroyed several maintenance buildings and could have taken most of the woodframe headquarters development with it. Luckily conditions for spread of fire were minimal on that day. Even so, the hot drafts from the fire blew roof shingles a mile away. As a result of this fire, all new construction in Ash Mountain had to be fireproof.

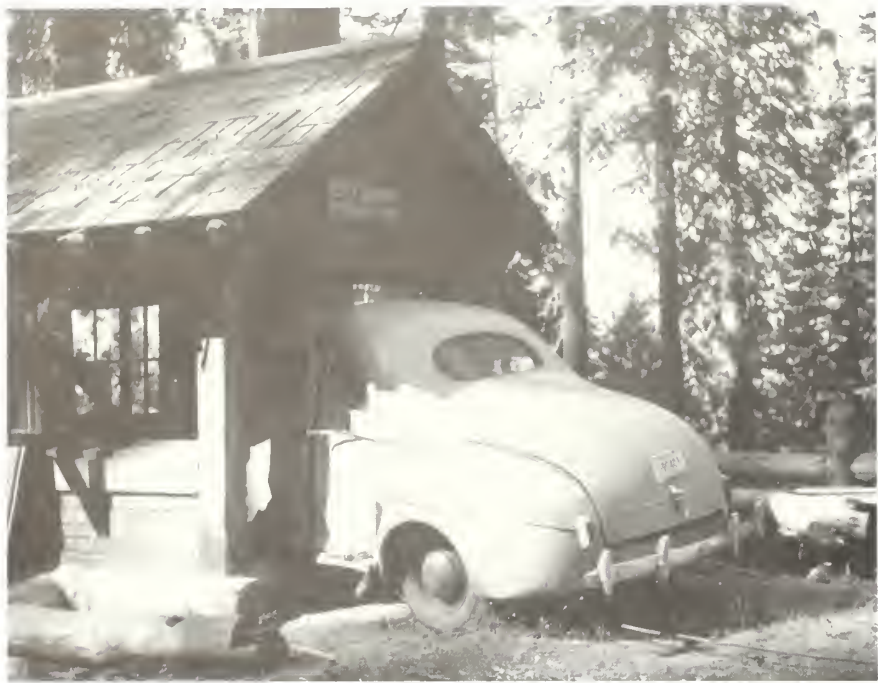
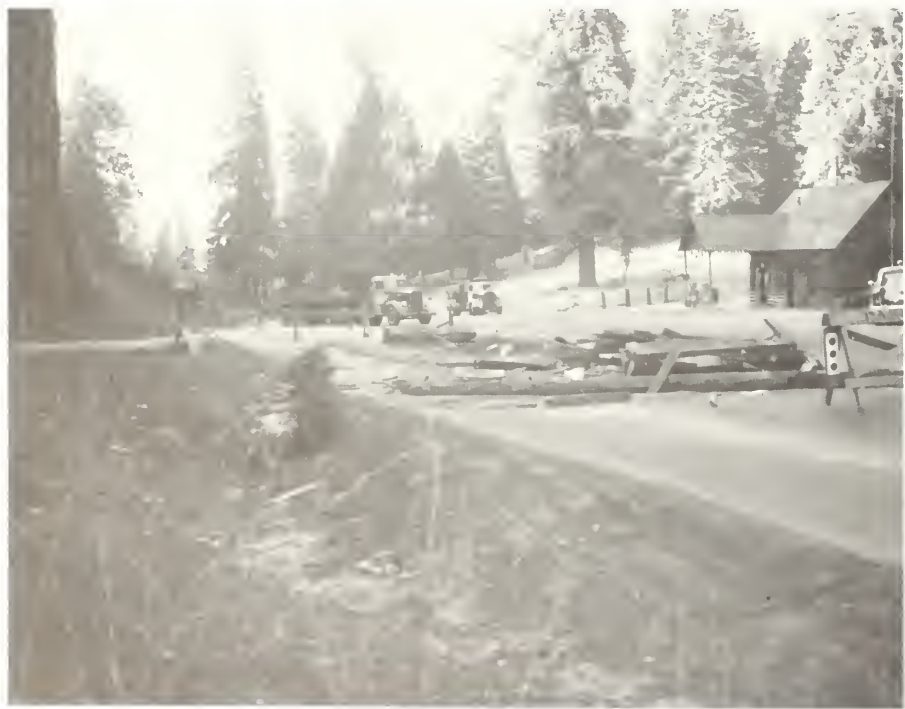
Vehicles have long been the bane of entrance stations. In 1950 the Lost Grove entrance station (above) fell victim to one. In 1957 a logging truck left only a pile of rubble where the Big Stump entrance station once stood (below).

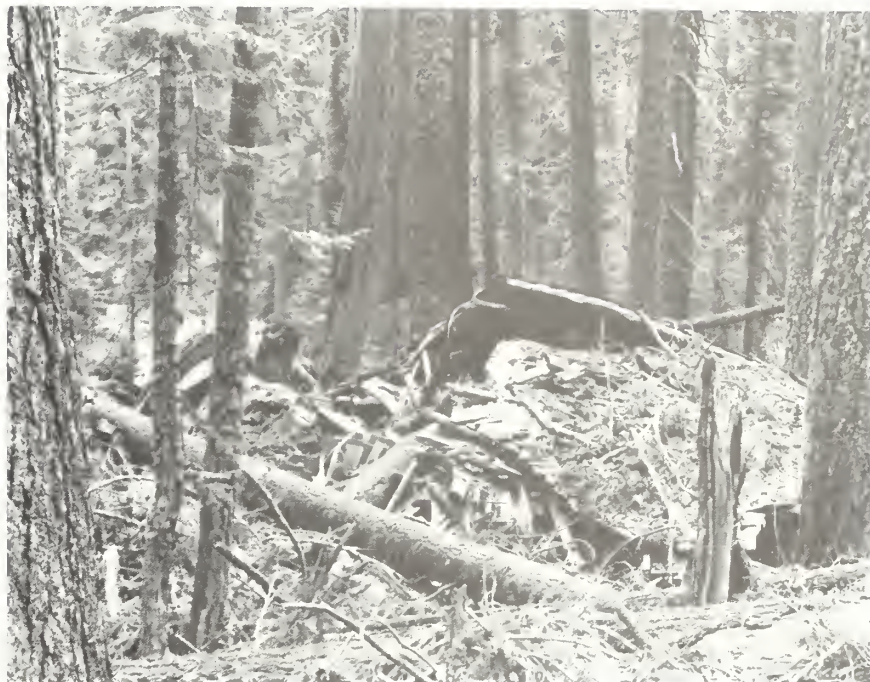
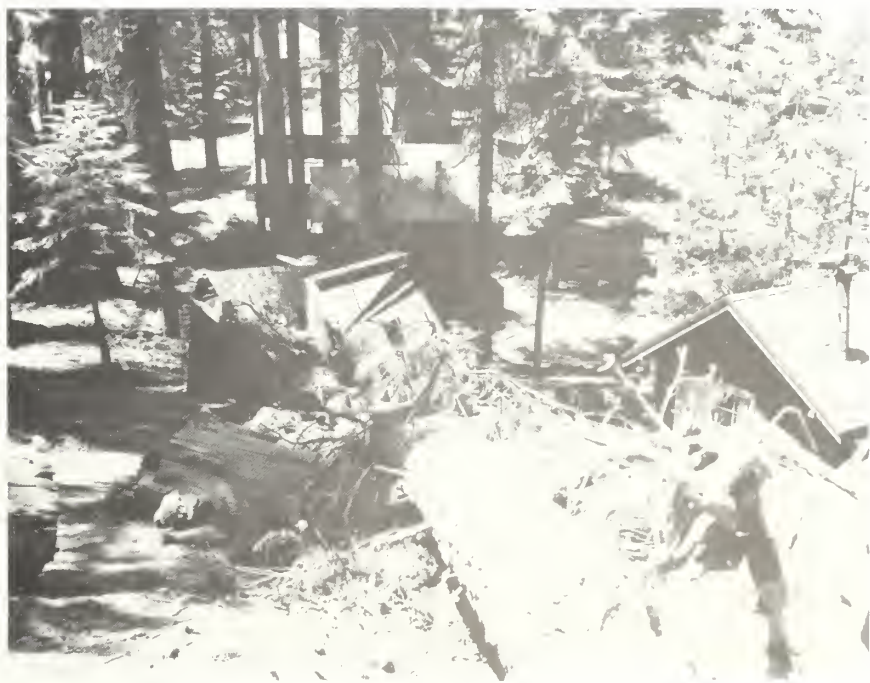
Hazard trees have destroyed a number of buildings in the parks. Both of these photographs taken in different decades in Giant Forest show the absolute destruction that a single tree can cause.

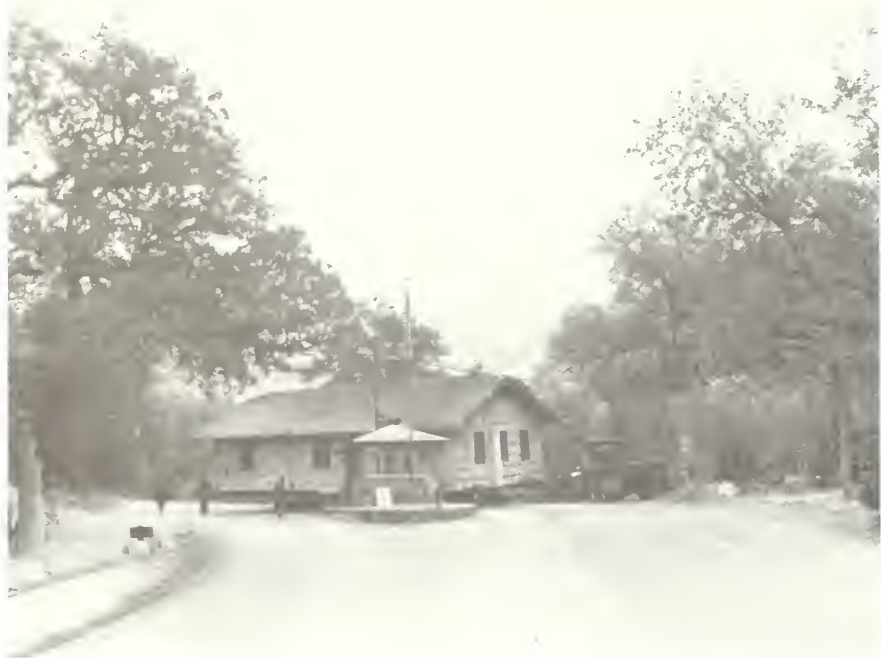
Moving buildings is a tradition in Sequoia and Kings Canyon. Among the many benefits of the post-and-block foundation is its lightness on the land. The building can be picked up easily and transported to another location. The building leaves a minimal scar.

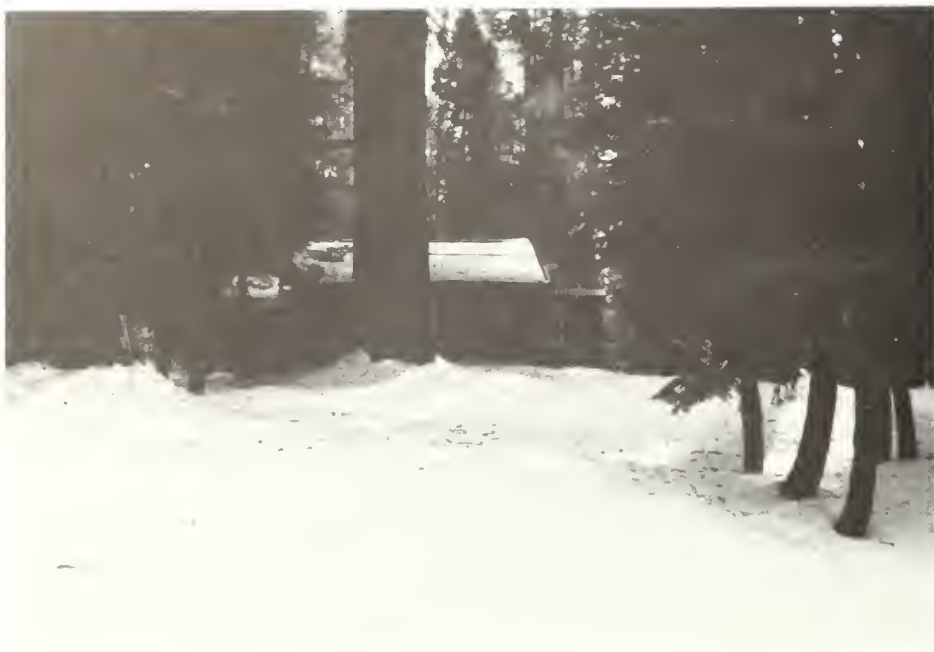
Building: Giant Forest Ranger Residence B-55

This building is a classic example of a structure built following the rustic design ethic. The building is listed on the National Register of Historic Places as part of Giant Forest Village Historic District.

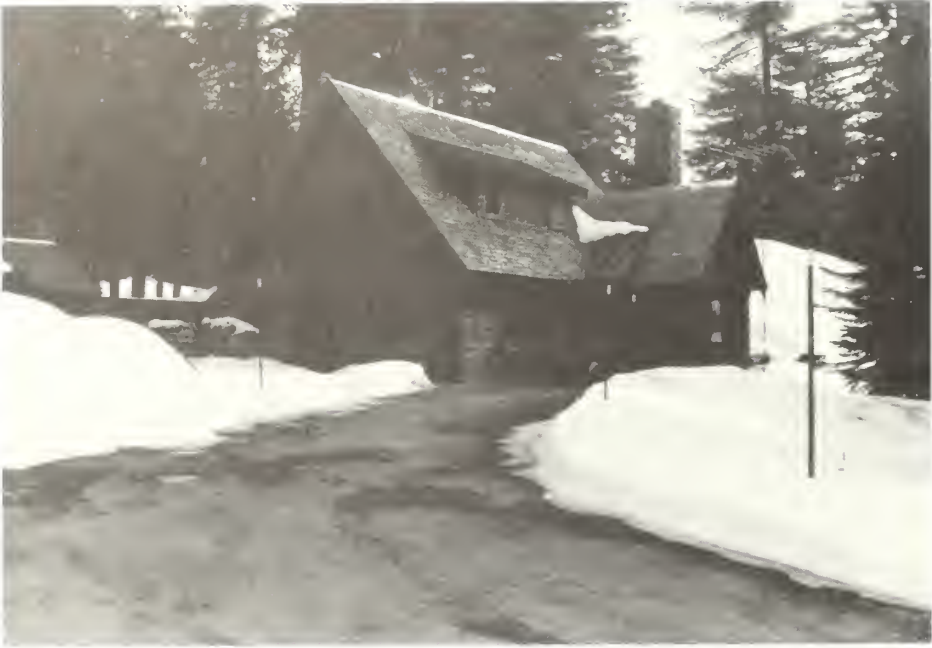
Building: General Grant N.P. Supt.'s Res. B-112

This building is the former Superintendent's Residence for General Grant National Park. It is listed on the National Register of Historic Places as part of the General Grant National Park Historic District.

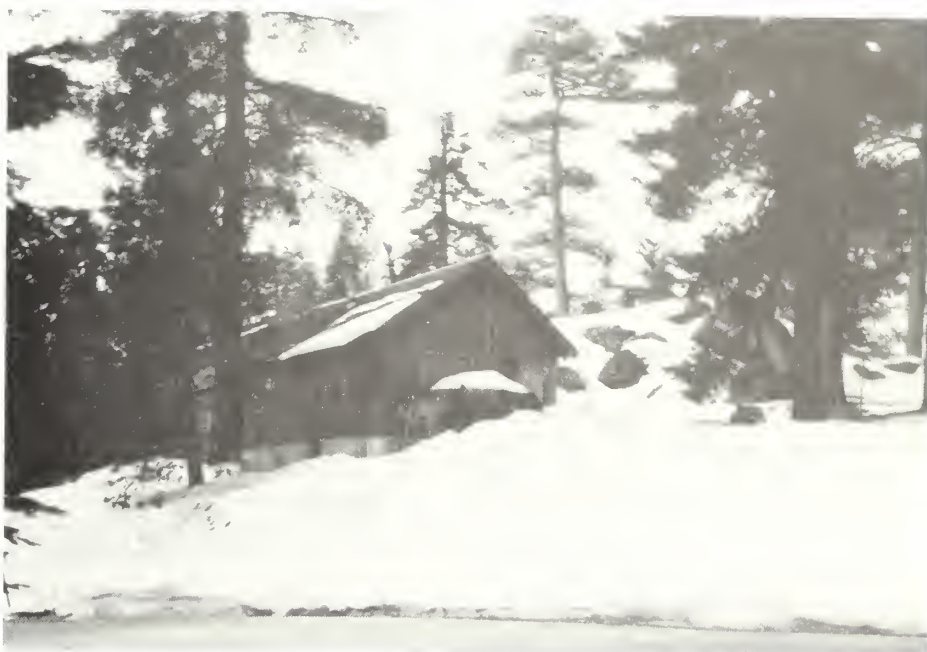
Building: Residence B-113

The building is loosely related to some of the structures of resort architect Gilbert Stanley Underwood (the Ahwahnee, Bryce Lodge, etc.) in the strength of its design.

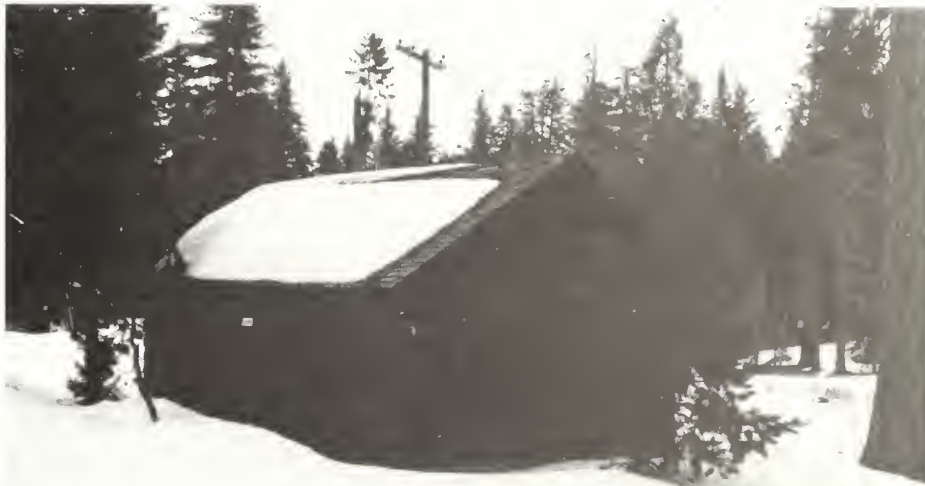
Building: Grant Grove Village Comfort Station B-251

This building is a slight variation on the rustic theme, and it contributes to the collective architectural identity of the parks.

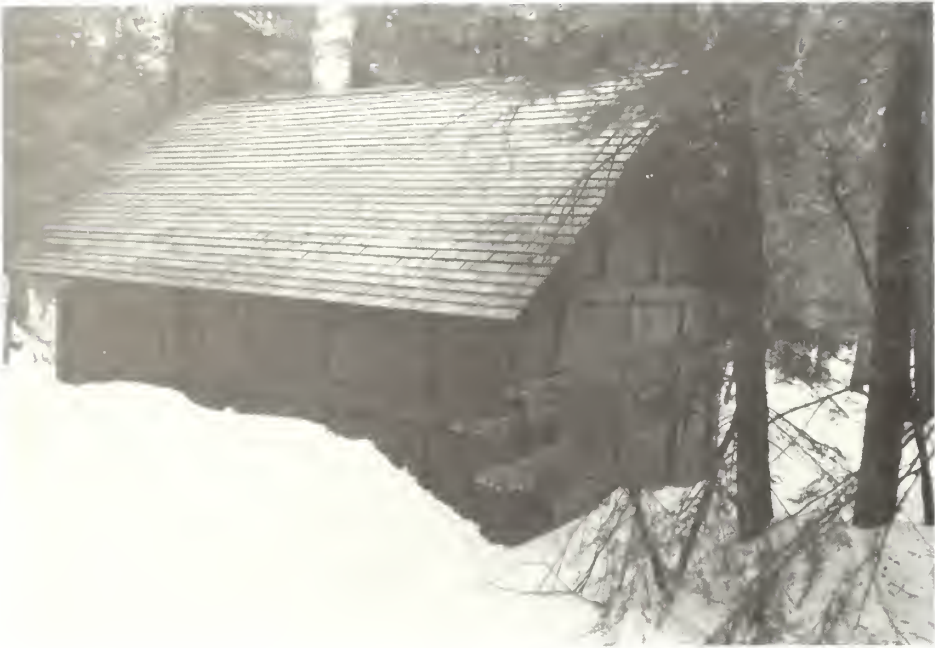
Building: Sunset Campground Comfort Station B-260

The form, materials, and interplay of masses and voids on this building are similar to those of architect Gilbert Stanley Underwood, designer of the Ahwahnee Hotel in Yosemite. This building is successful in its progressive rustic style and in its updated use of materials.
